Damage Evaluation Report

“SALT SHAKER”

2011 RIPTIDE 280 WA

DAMAGE EVALUATION REPORT

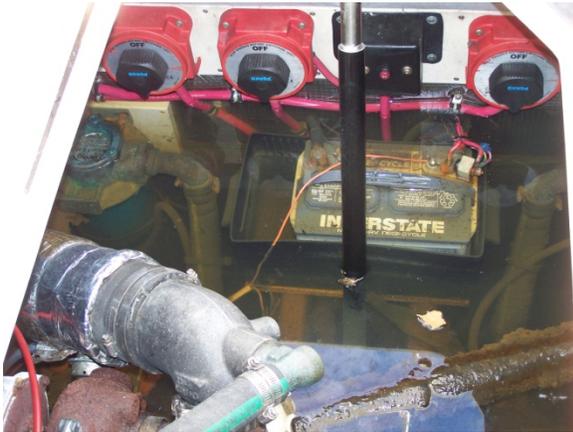
Photos 1, 2, and 3 (provided by the owner) show the extent of submersion in the main cabin and engine room at time of discovery. Pictures 4, 5, and 6 shows the engine room and main cabin as it appeared on the day of inspection.

The engine compartment was filled to approximately $\frac{3}{4}$ of its depth (this varied due to the angle of the vessel) meaning both transmissions were completely submerged and the engines were submerged aft to a point just above the bottom of the turbochargers.

Photo 1: Flooded engine compartment

1. Based on estimated length of submersion, lack of damage mitigation after submersion and the amount of external corrosion noted, it is assumed both engines and transmissions are beyond the point of repair and will need to be replaced.

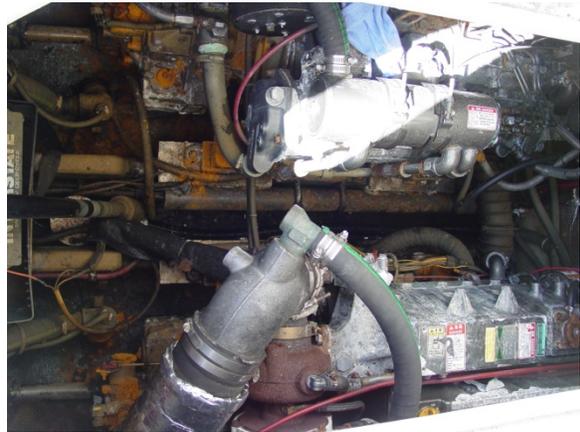
Photo 4: Engine compartment

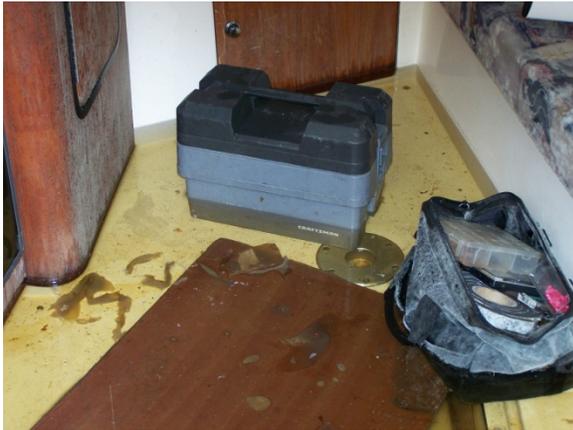
Based on the photos provided by the owner and observations made during the inspection (measurements of interior watermarks, etc) the main cabin filled to a depth at least 4 inches above the cabin sole – more so aft due to the angle of the hull. Water damage to the lower edges of the wood cabinet framework, cabinet doors, etc, was also sighted and there was a significant amount of mold and mildew present.

Photo 2: Flooded main cabin

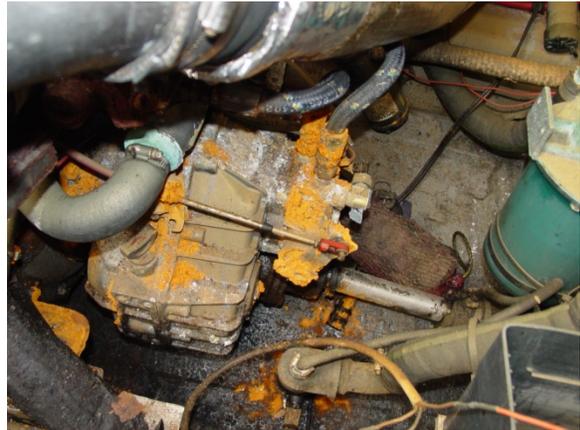
Photo 5: Example of engine corrosion

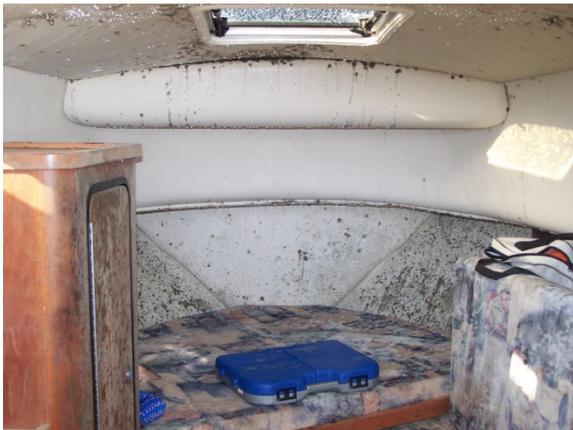
Photo 3: Mold and mildew in main cabin
cabin

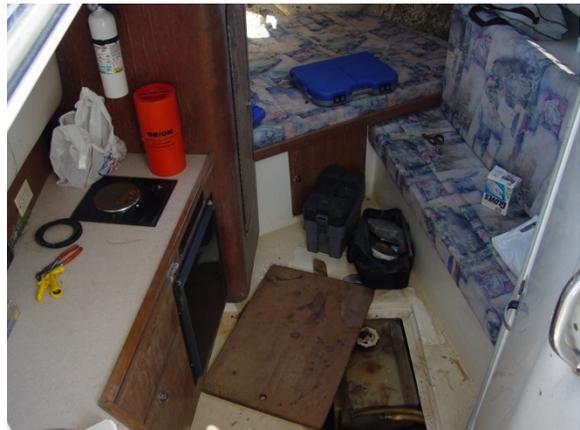
Photo 6: Main cabin
