## **Pre-Purchase Condition and Value Survey**

### **“WINDFALL”**

### **2005 FASTONE 36**

**PRE-PURCHASE CONDITION AND VALUE SURVEY REPORT**

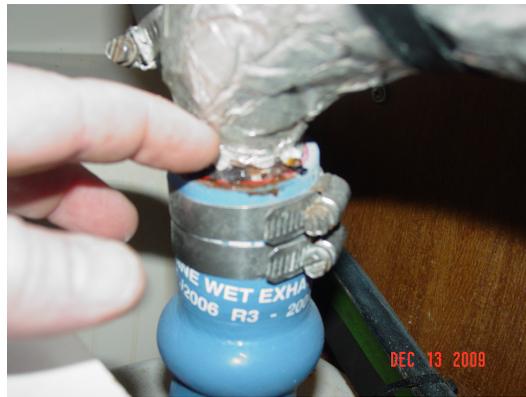
B-13

Comments: **See recommendation B-13.**
