Pre-Purchase Condition and Value Survey

“SALT SHAKER”

1982 Largo 35 Sport Fisherman

PRE- PURCHASE CONDITION AND VALUE SURVEY REPORT

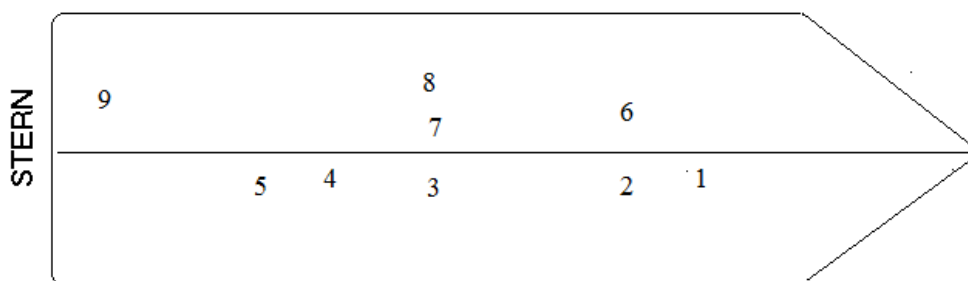
1. Type: Holding tank overboard discharge.
Comments: Good as seen. Seacock operational.
2. Type: Unused and capped.
3. Type: Deck wash down intake.
Comments: Good as seen. Seacock operational.
4. Type: Starboard engine raw water intake.
Comments: Good as seen. Seacock operational.
5. Type: Garboard drain plug.
6. Type: Head raw water intake.
Comments: **See recommendation B-4.**
7. Type: Port engine raw water intake.
Comments: Good as seen. Seacock operational.
8. Type: AC unit raw water intake.
Comments: Good as seen. Seacock operational.
9. Type: Generator raw water intake.
Comments: **See recommendation A-1.**

- A-1 The raw water intake hose for the generator is deteriorated and in poor condition. Recommend it be replaced prior to launch by a competent marine technician.

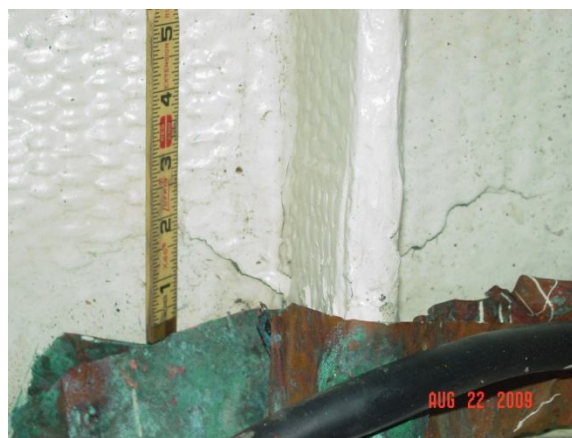
B-2.B

- B-2 Broken stringer, floor, and bulkhead FRP tabbing were sighted in the engine compartment outboard of both the starboard engine (see photos B-2.A & B) and port engine (see photo B-2.C). An approximately 2 inch crack was also sighted in the bulkhead forward and outboard of the port engine (see photo B-2.D). The above are typical indications of excessive hull flexing and movement. As it appears the vessel was originally powered with gasoline engines, the flexing is likely due to the installation of heavier, more powerful diesel engines during the vessel's repower. If that is the case, repairs of the damaged areas must be designed to exceed their original strength to prevent future failures. Recommend each of the above areas be inspected, evaluated, and repaired using best industry practice by a competent marine repair facility.
