## **Pre-Purchase Condition and Value Survey**

### **“WINDFALL”**

### **2005 FASTONE 36**

**PRE-PURCHASE CONDITION AND VALUE SURVEY REPORT**

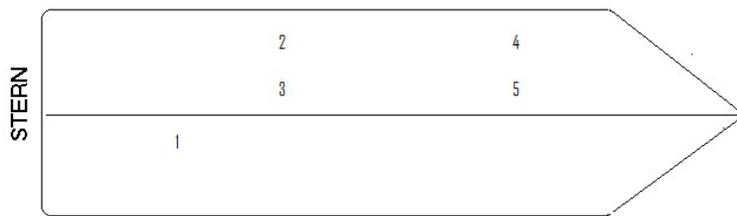
**THROUGH-HULLS (below static waterline)**

1. Type: Engine raw water intake.  
Comments: Good as seen. Seacock operational.
2. Type: Holding tank macerator overboard discharge.  
Comments: Good as seen. Seacock operational.
3. Type: Galley sink drain.  
Comments: Good as seen. Seacock operational.
4. Type: Head sink drain.  
Comments: Good as seen. Seacock operational.
5. Type: Head raw water intake.  
Comments: Good as seen. Seacock operational.
