Vessel Appraisal Report

1990 FASTCRAFT XLT

Hull Identification Number: ABCDE1234567

File Number: 02288906AP11

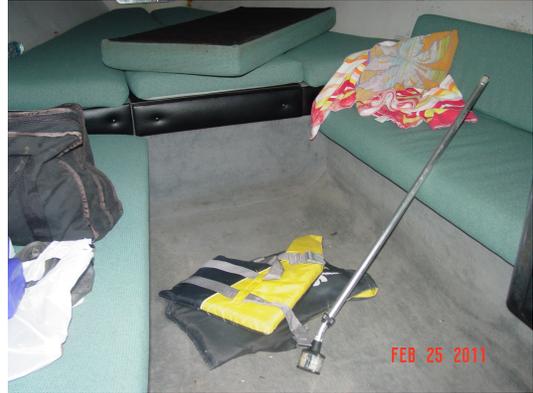
Forward cabin

The vessel has a small V-berth cabin forward. Aft of the V-berth is the helm to starboard, with captain's chairs to port and starboard. Next aft is the cockpit, which is followed by the engine compartment. A single engine hatch provides reasonable service access to the engine.

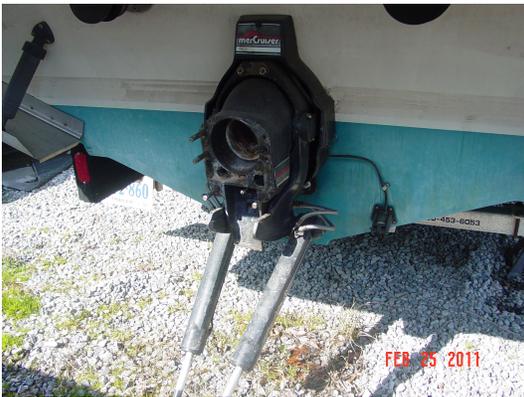
Stern drive

The vessel was in average condition overall. The outdrive was disassembled and missing the lower unit, which has been removed for repairs as per the owner. As such, she was not mechanically operational at time of appraisal. The engine was reportedly operational, however this could not be confirmed as the vessel was trailerized and under repairs.

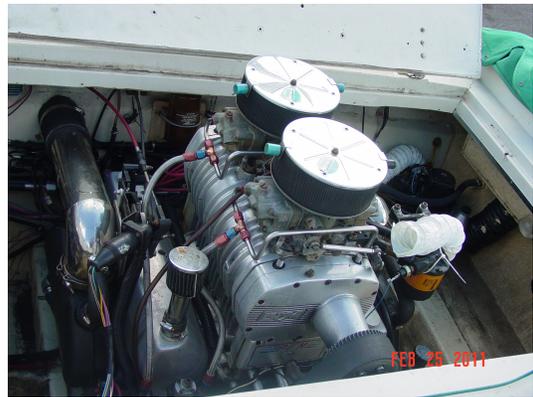
Engine

The hull is of solid fiberglass, while the decks and superstructure are a combination of solid and internally cored construction. Power is provided by a single gasoline engine (reportedly a Chevrolet 454) located on centerline aft of the cockpit (no engine data tag was sighted). The engine is equipped with a S&M blower assembly and powers a MerCruiser outdrive unit.
